CHAMCLAD FIRE TEST REPORT

NFPA 268 TESTING ON EXTERIOR WALL ASSEMBLY CONTAINING CHAM-CLAD PVC CLADDING

M1959.01-121-24 R1

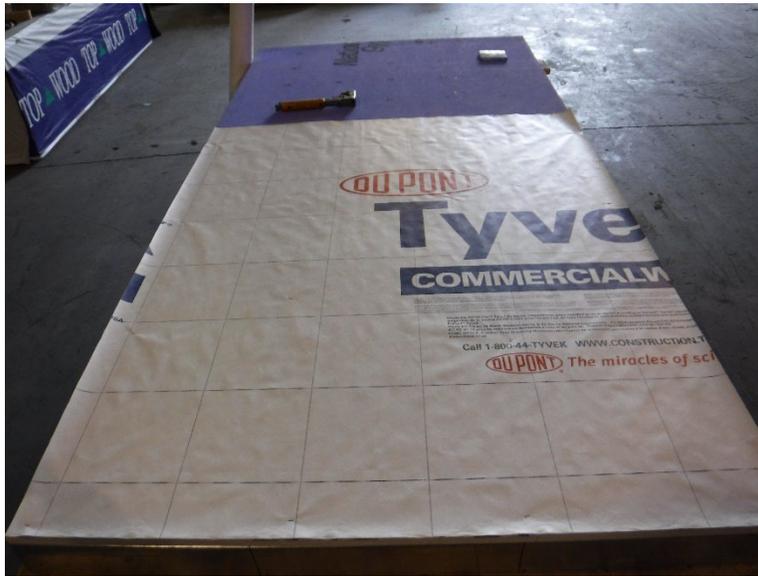
Photo No. 1
Construction of Test Assembly

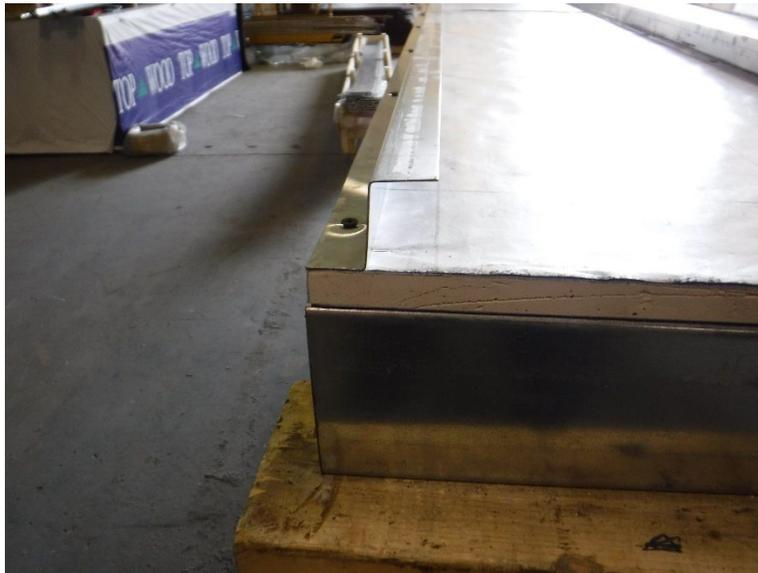
Photo No. 2
Z-girt Installation

20 gauge aluminum 1 1/2" high Z-girts were installed vertically on the 8' perimeters and secured using #6 x 20 x 1 1/4" self-drilling drywall screws every 12". 20 gauge aluminum 1 1/2" Hat Channels were installed vertically at the stud locations and secured on one side using #6 x 20 x 1 1/4" self-drilling drywall screws every 12".

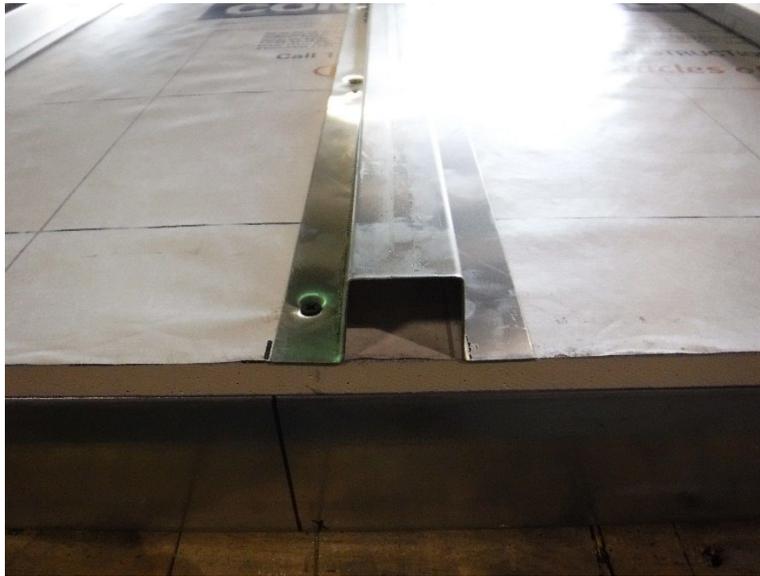
Photo No. 3
Hat Channel Installation

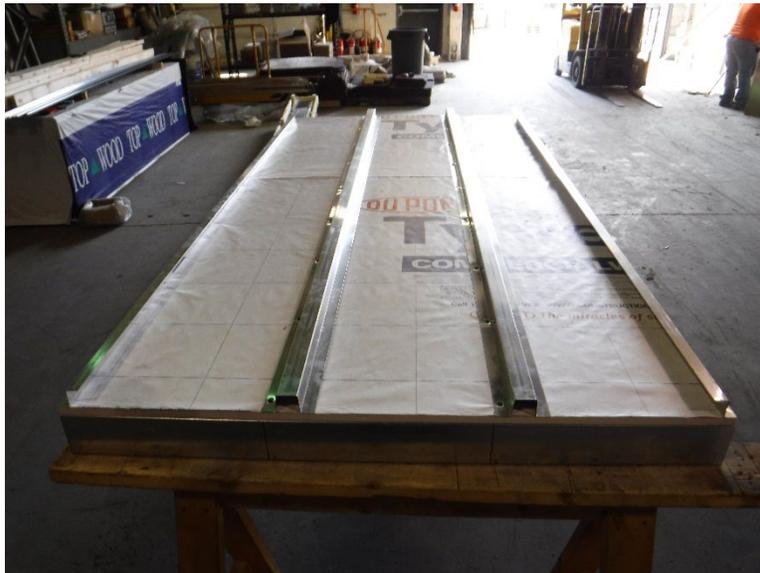
Photo No. 4
Complete Z-girt and Hat Channel Installation

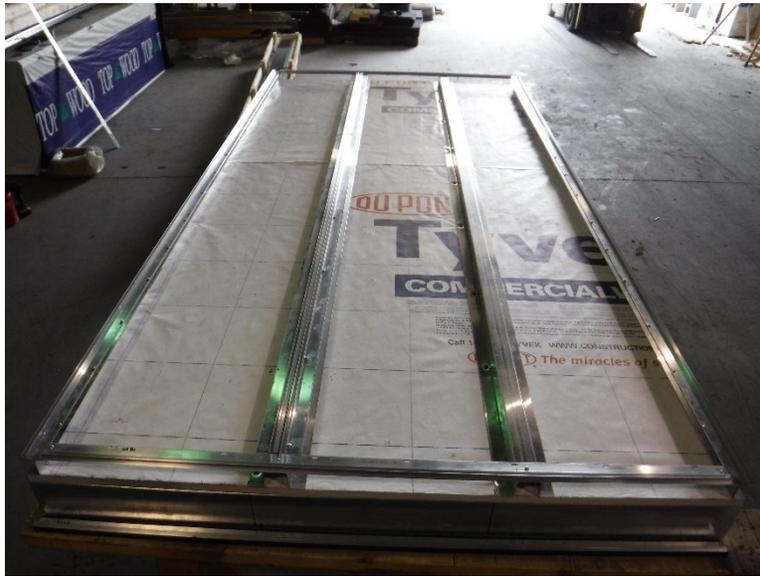
Photo No. 5
Complete Starter Strip Finishing Trim Installation

A single piece of 0.056 aluminum starter strip was placed vertically directly on top of the aluminum Z-girts and one of the hat channels. Two pieces of the starter strips were placed back to back on top of one hat channel to create a joint detail. Additionally, one piece of starter strip was placed horizontally at the top and bottom of the wall assembly to create a perimeter grid system. The vertical starter strips were fastened every 6" using #6 x 20 x 1/2" self-drilling stainless steel screws and fastened at the stud locations horizontally. **(See Construction Photos in Section 10, Page 10)**

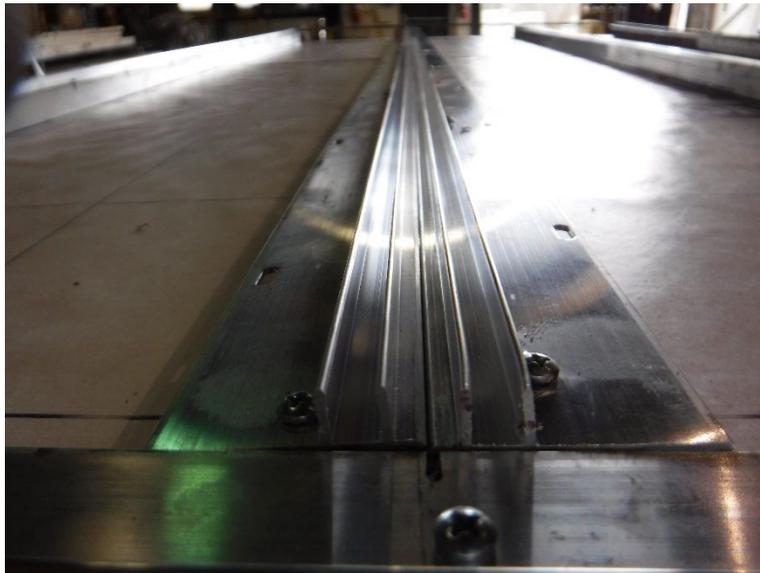
Photo No. 6
Back to Back Starter Strip Installation

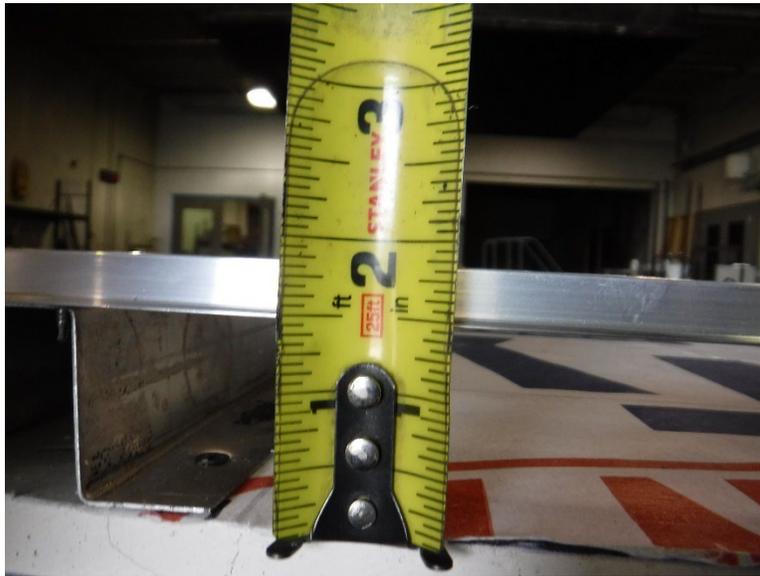
Photo No. 7
1 1/2" Air Cavity

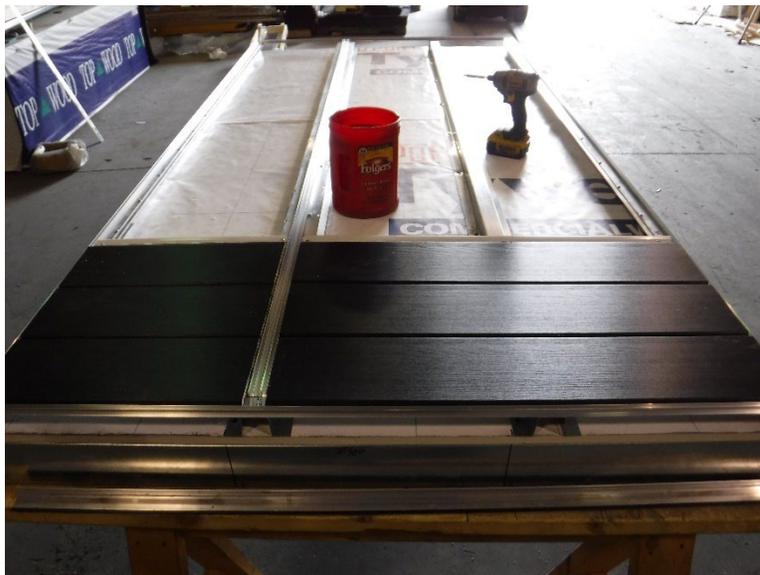
Photo No. 8
Installation of Cladding

Cham-Clad PVC cladding was installed and placed between the starter strips, cut 1/8" shorter to allow for expansion and contraction, and fastened using #6 x 20 1/2" self-drilling stainless steel framing screws. A joint was utilized at one of the interior stud locations.

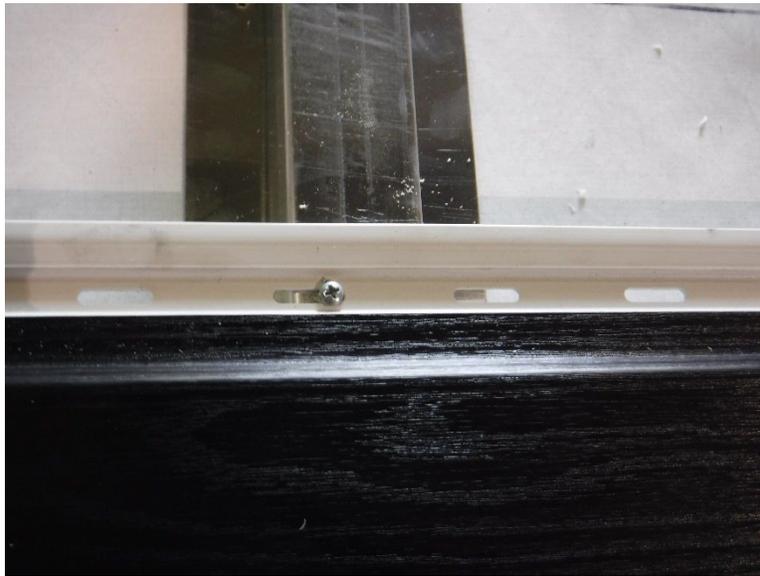
Photo No. 9
Fastening of Cladding on Hat Channel

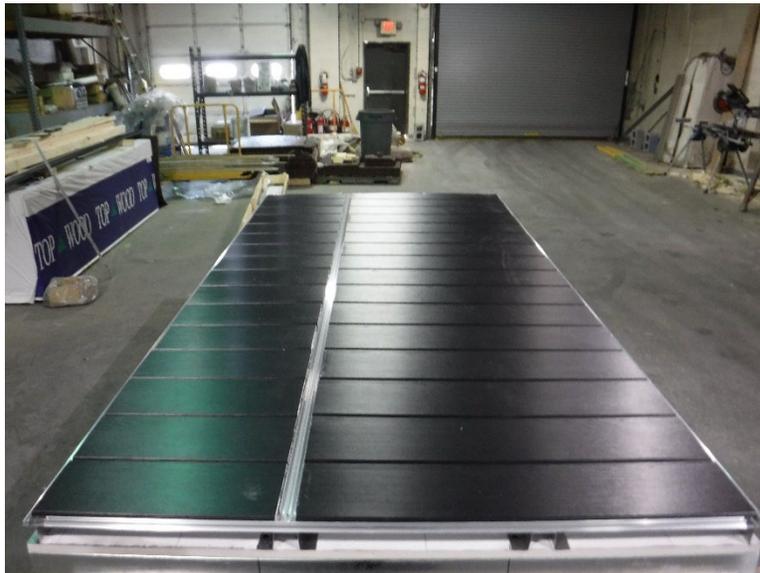
Photo No. 10
Complete Cladding

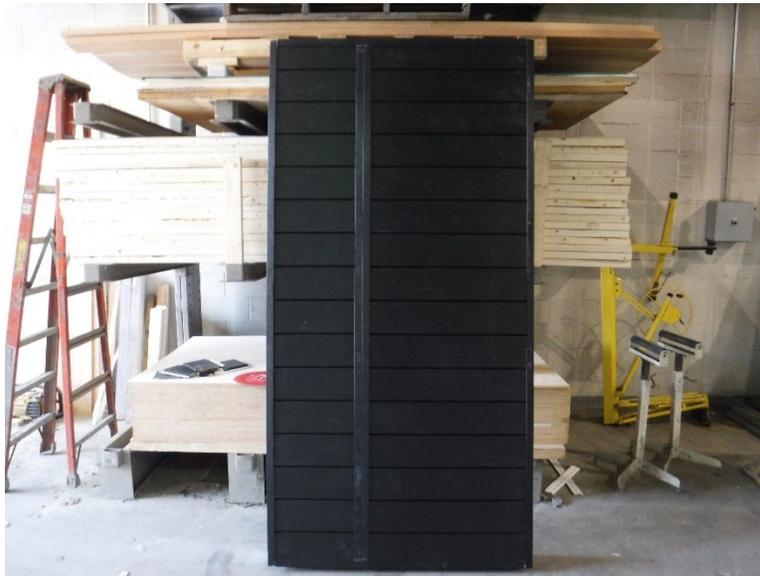
Photo No. 11
Complete Test Assembly

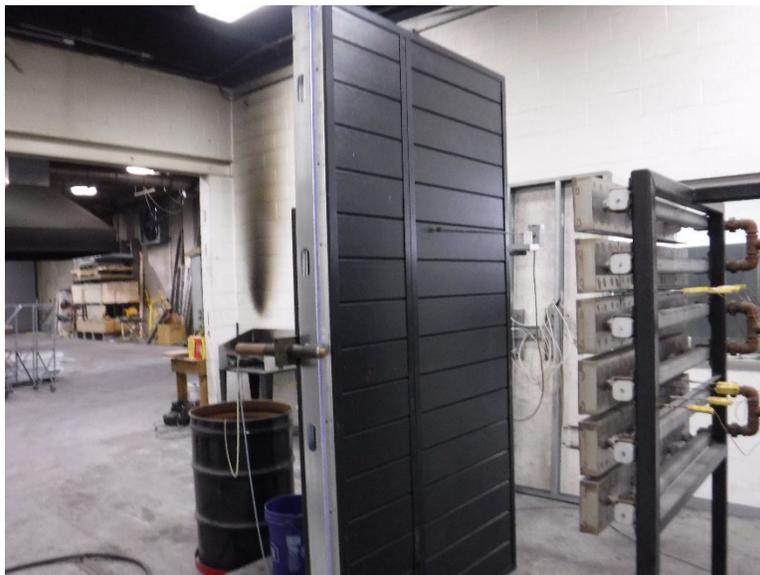
Photo No. 12
Complete Assembly (Pre-test)

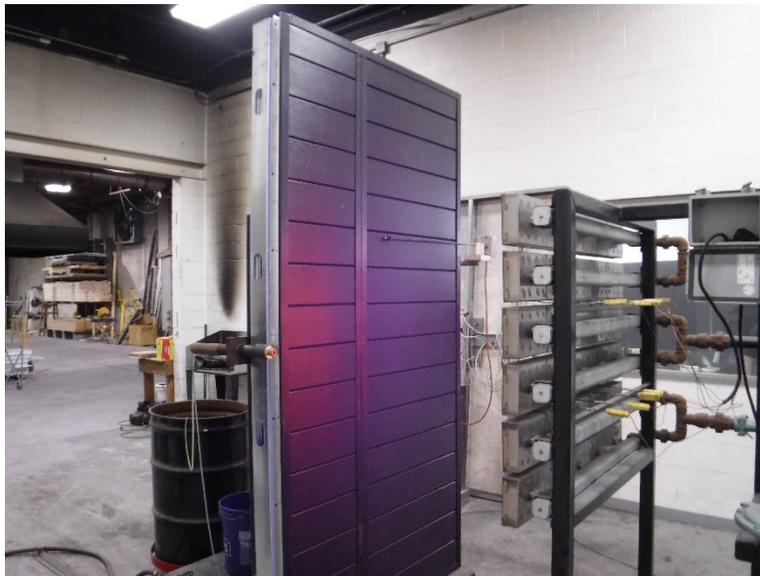
Photo No. 13
Initiation of Test

00:00	Radiation shield removed. Test begins.
01:21	Warping of cladding
01:42	Smoke emitting from test assembly
02:58	Surface bubbling of cladding
04:02	Separation of horizontal cladding joints

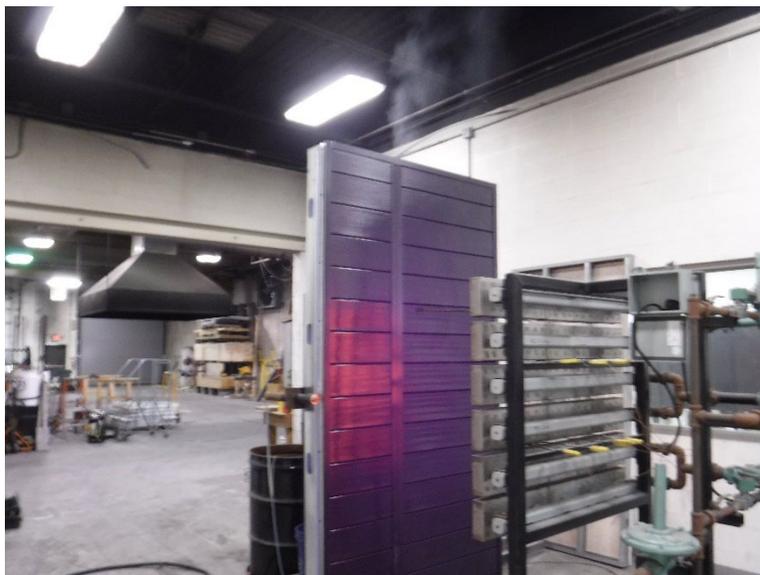
Photo No. 14
Warping of Cladding and Smoke Emitting From Assembly

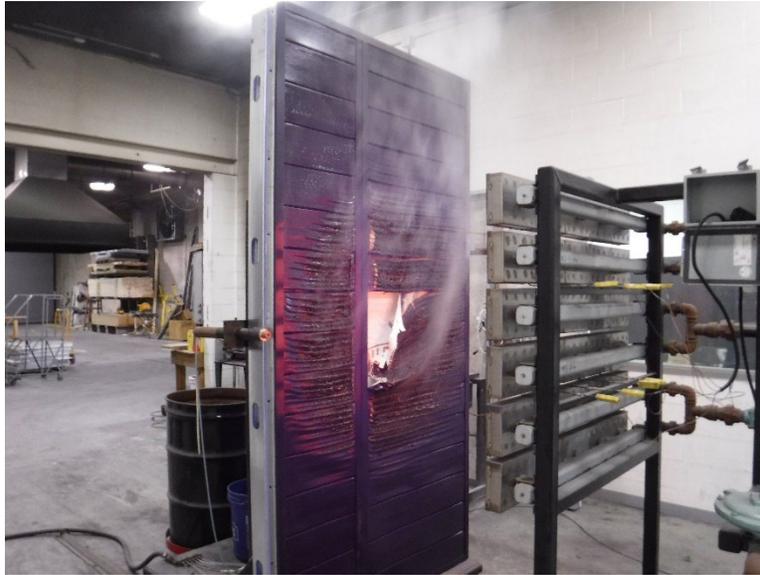
Photo No. 15

Dislodged Cladding on Long Side with Exposed Tyvek®

06:22	Cladding dislodging from trim on the long side exposing the Tyvek® air and water barrier
07:11	Tyvek® melting exposing the exterior sheathing
09:30	Cladding dislodging from the trim on the short side exposing the Tyvek® air and water barrier

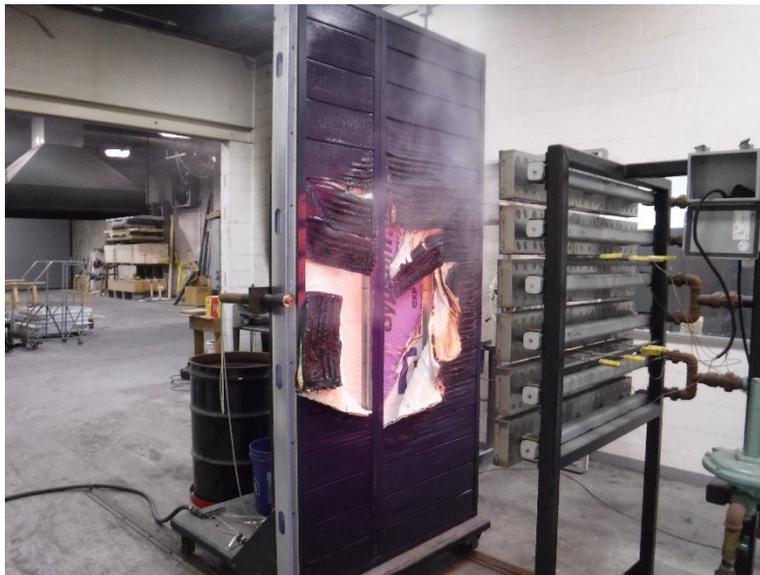
Photo No. 16

Dislodged Cladding on Short Side with Exposed Tyvek®

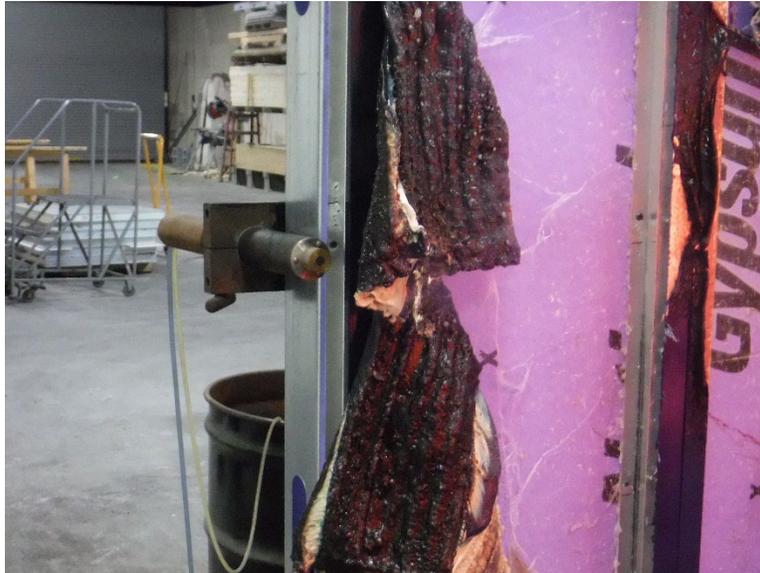
Photo No. 17

Cladding in Front of Reference Heat Flux Meter

11:30	Cladding on the short side melting in front of the reference heat flux meter
11:46	Surface paint peeling from trim perimeter cap
13:41	Cladding melting onto spark ignitor

NOTE: The Decline Shown in the Above Graph was Created by a Melted Piece of PVC Cladding Blocking the Reference Heat Flux Meter. See Photo #17 on Page 16 of this Test Report.

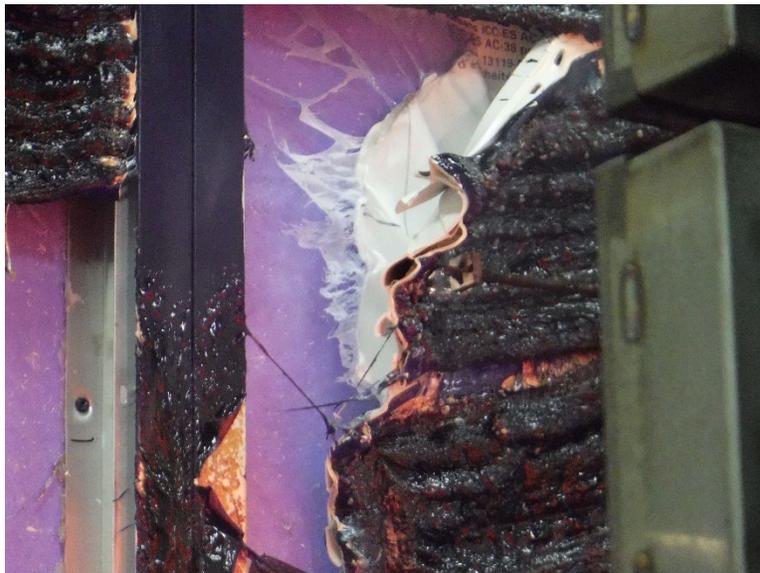
Photo No. 18

Cladding Melting onto Spark Ignitor

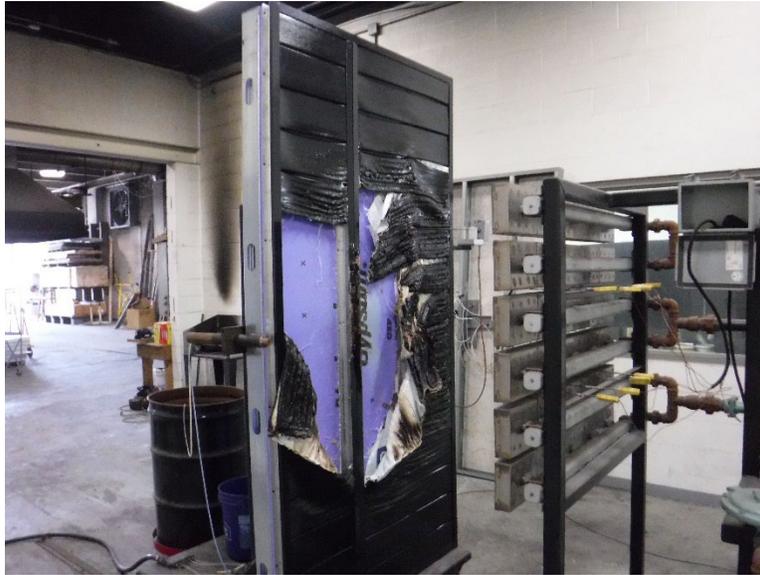
Photo No. 19
Post-test Exterior

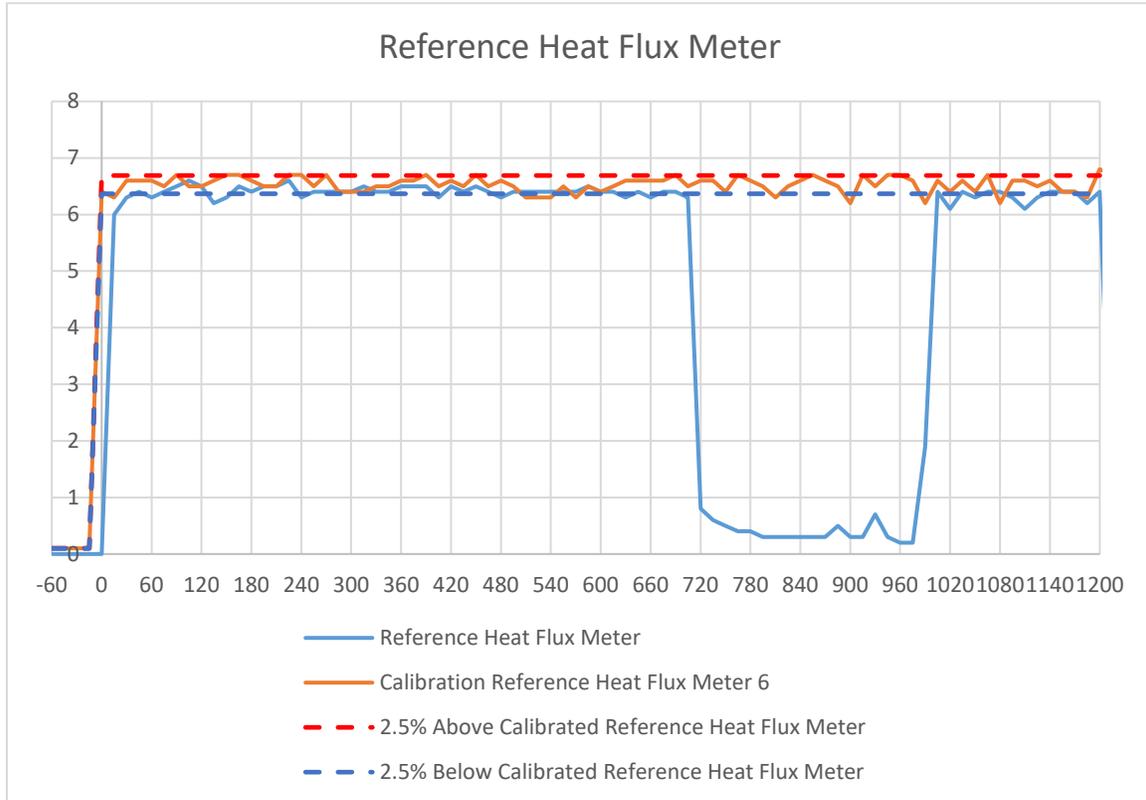
Graph No. 2

Reference Heat Flux Meter

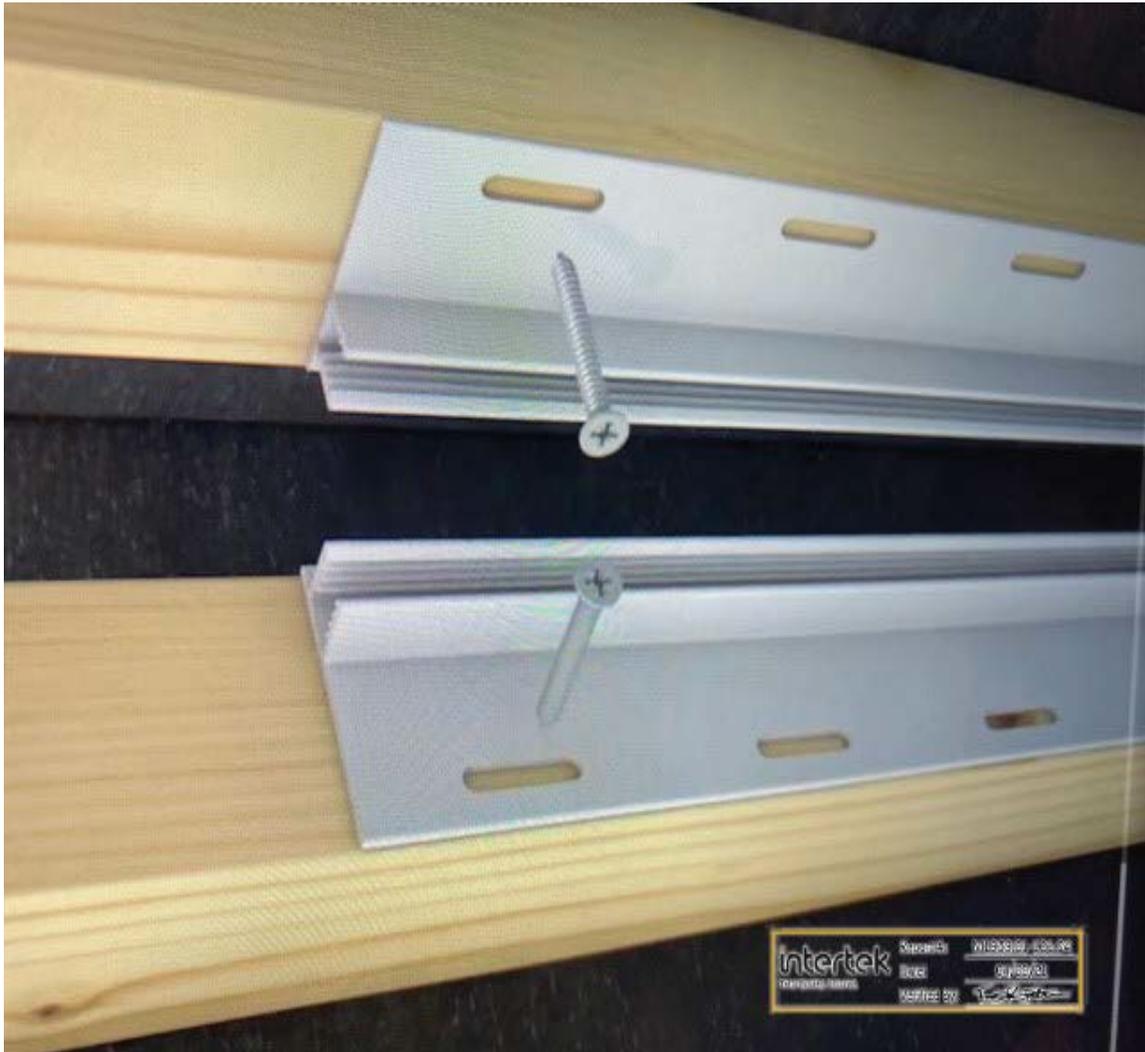
2 PIECE FINISHING TRIM STARTER STRIP INSTALLTION

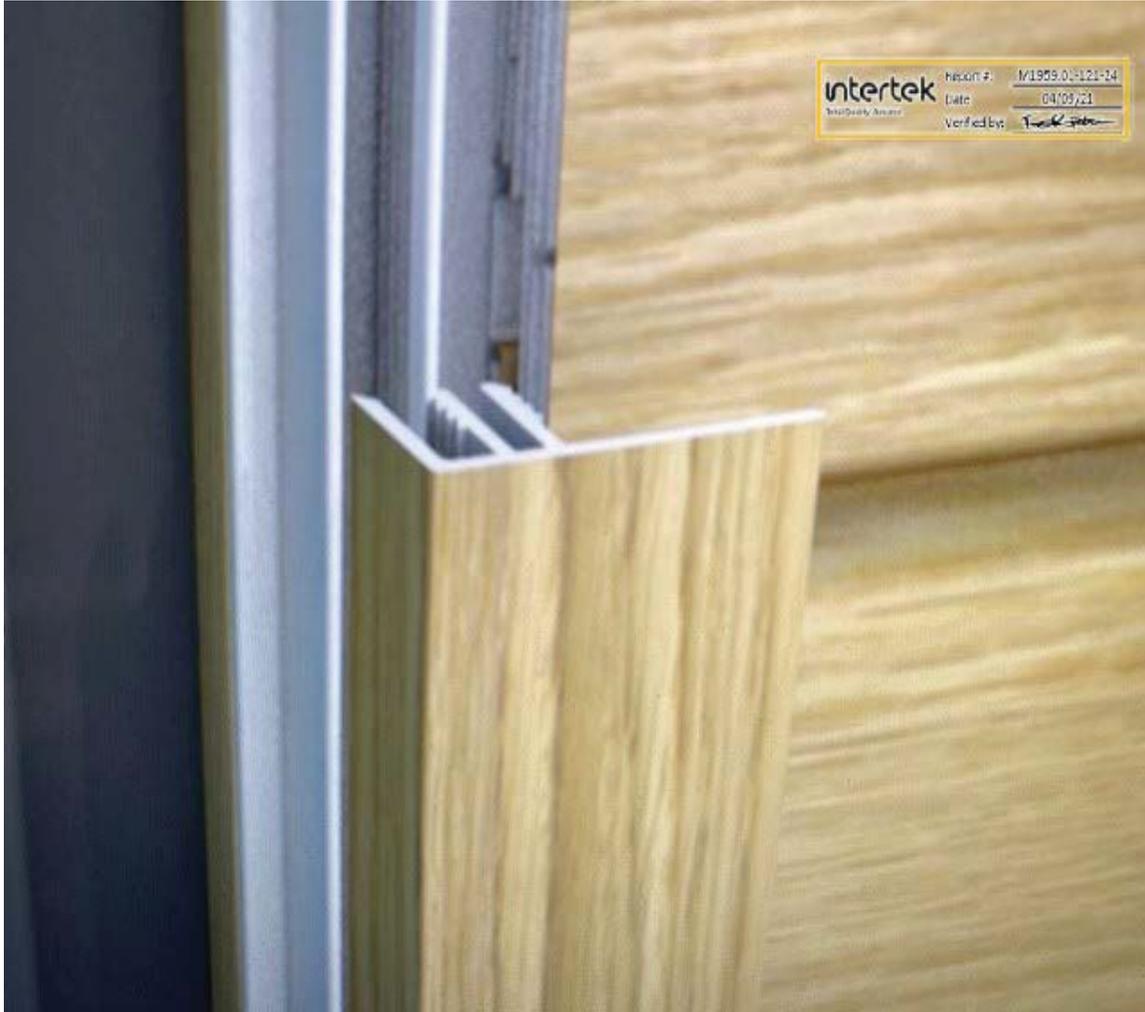
2 PIECE FINISHING TRIM PERIMETER CAP INSTALLATION

A 0.075 aluminum perimeter cap was applied onto the starter strip, completing the finishing trim.
